SEGA OF AMERICA, INC.  
Consumer Products Division

# **32X Technical Information**

Doc. # MAR-41-R8-090694

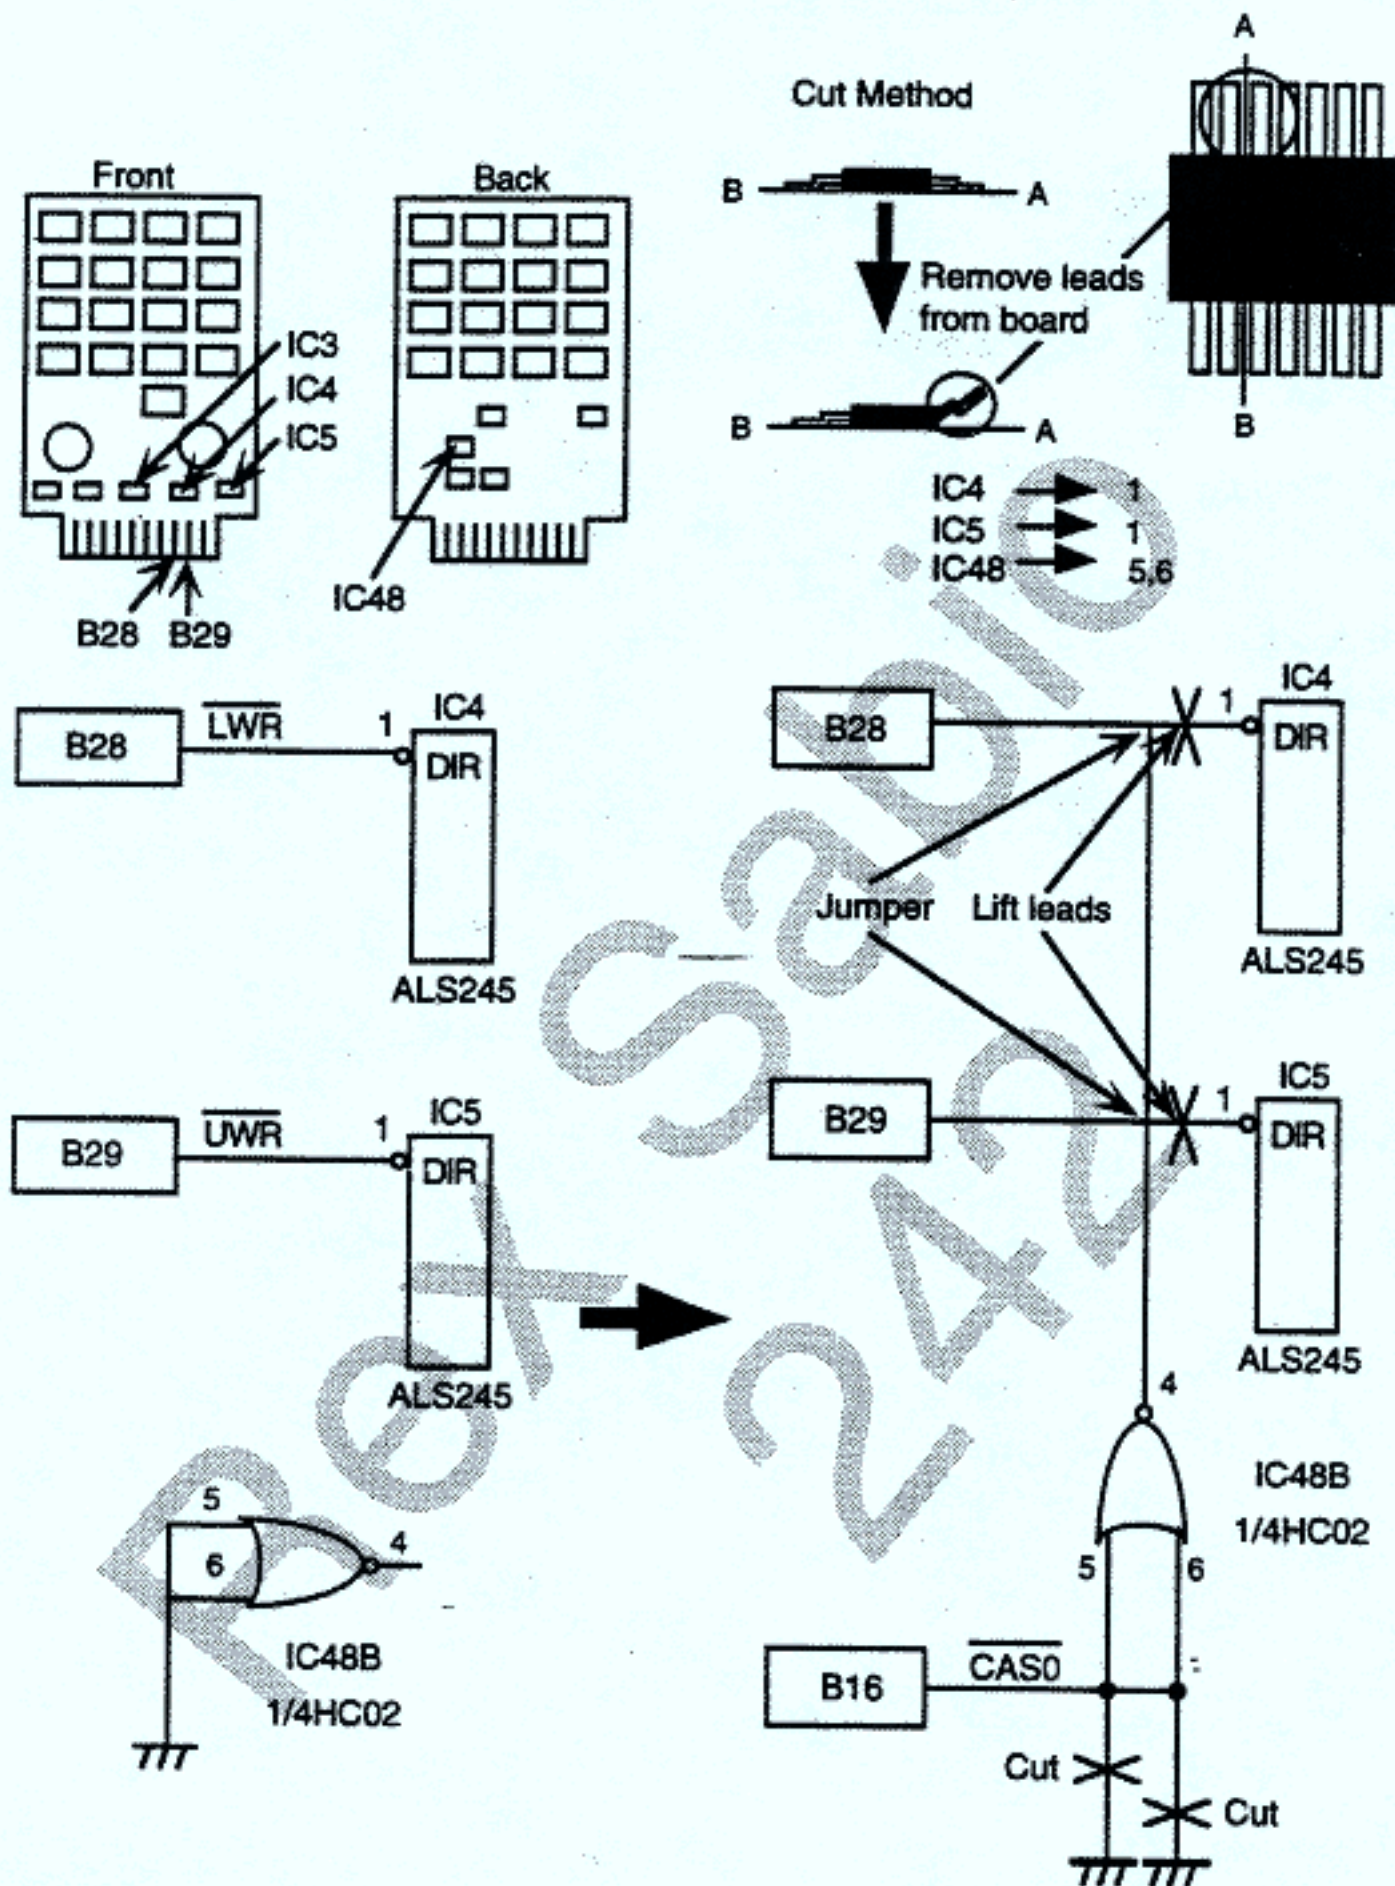
- The following modifications are necessary when a Mega Drive 32 Mbit SRAM board is used with the 32X.

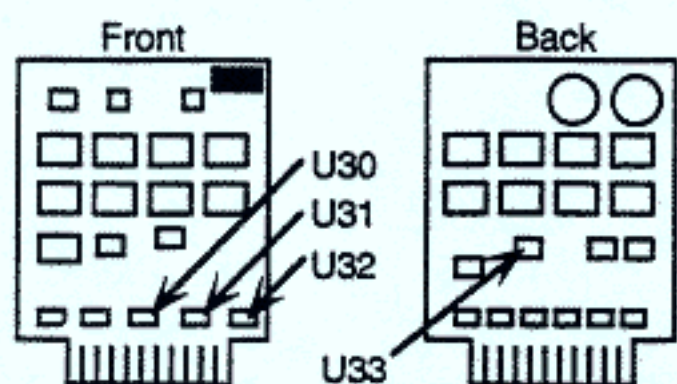
- The following modifications are necessary when a Mega Drive 16 Mbit SRAM board is used with the 32X.

- Lift no. 1 pins of U31 and U32.
- Similarly, lift no. 13, 14, and 15 pins of U33.
- Jump the no. 16 pin of U30 and the no. 13 and 14 pins of U33.
- Connect the no. 15 pin of U33 to the GND (no. 8 pin).
- Jump the no. 9 pin of U33 to each no. 1 pin of U31 and U32.

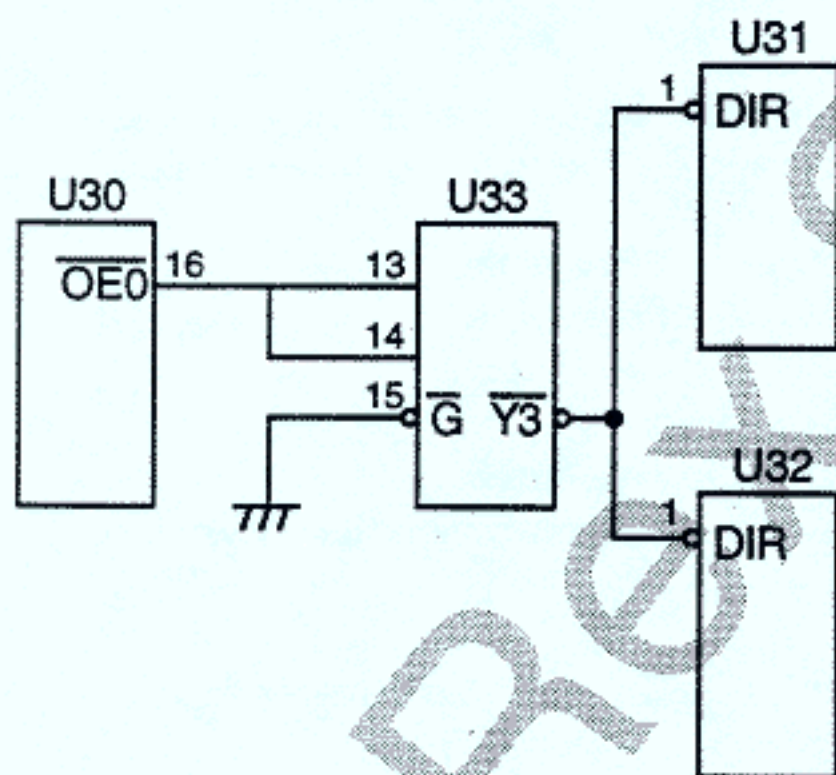
#### After Modification

Operation cannot be guaranteed if U31 and U32 are not AC or ALS type. If equipped with the LS type, the AC or ALS type should be attached, replacing the LS type.

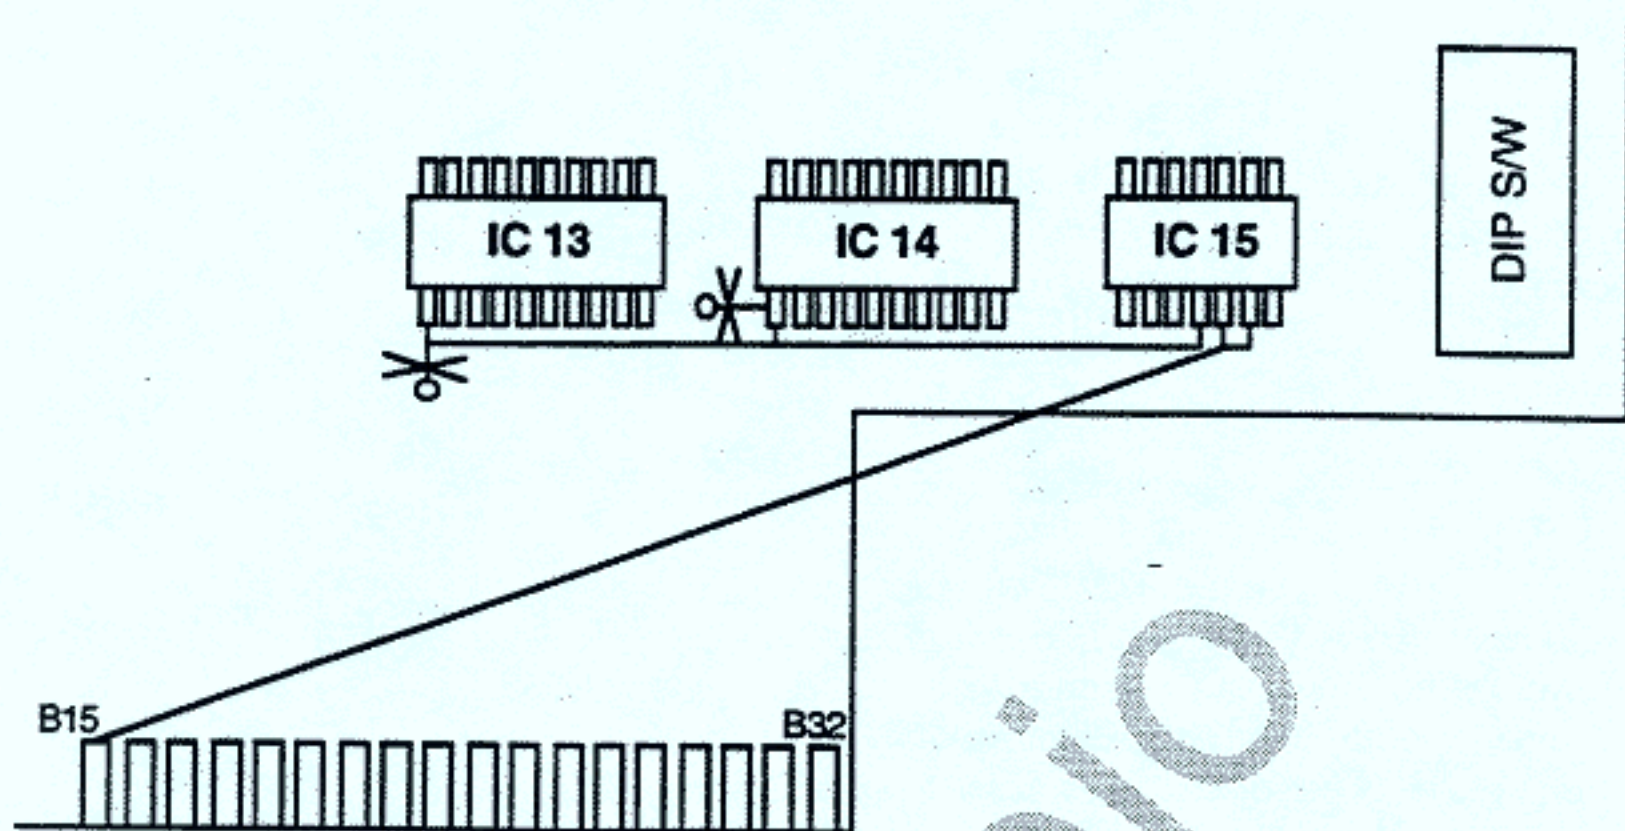
3. The following modifications are necessary when a Mega Drive 32 Mbit ROM board is used with the 32X.

1. Cut between the pattern of the IC13 no.1 pin and the through-hole below the pin.
2. Cut between the pattern of the IC14 no.1 pin and the through-hole to the left of the pin.

3. Cut the trace pattern of the IC 15 no.5 and no.6 pins.
4. Wire (connect) IC13 no.1 pin, IC14 no.1 pin, and IC15 no.4 pin.
5. Wire (connect) th IC 15 no.5 and no.6 pins to B16 of the card edge.
